Reactivation of former watercourses to support urban stormwater management

Simperler L., Glanzer M., Ertl T., Kretschmer F.*

University of Natural Resources and Life Sciences Vienna, Institute of Sanitary Engineering and Water Pollution Control,
Muthgasse 18, 1190 Vienna, Austria

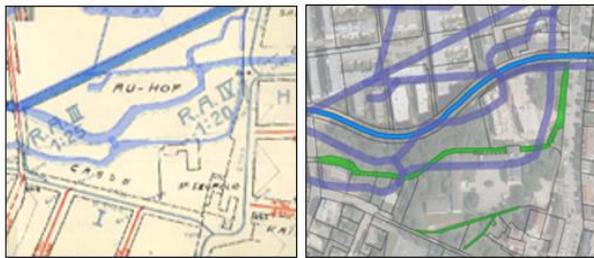
Figure 1. left: old site plan extract of the investigated area with river courses from 1917, right: digital orthophoto extract with currently existing river course (blue), the old river courses from 1917 (pale blue) and narrow premises which could be a possible indicator for residues of oxbows (green)

In cooperation with the municipal utilities of Wiener Neustadt an investigation area was defined, and old site plans were provided. Primary data sources were an old plan with former river courses from 1917 plus several plans of an existing drainage system. These site plans were digitalized and incorporated into a GIS model using the open source software QGIS (see Figure 1). Based on the currently digital land register and the overlapped digitalized old river courses several possible locations of oxbow residues could be determined.

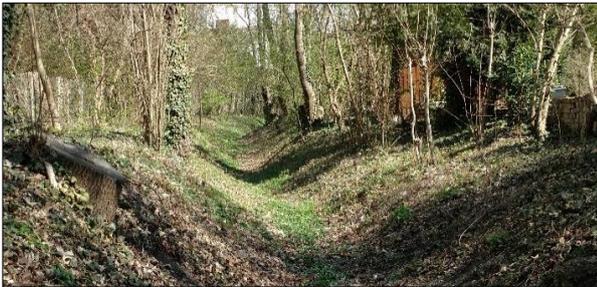
Figure 2. example for a still existing channel from the case study site (2019)

To achieve a better knowledge of the hydrological interrelations of the study site several other relevant projects and studies were incorporated into the GIS model (e. g. the digital cadaster of the municipal sewer, groundwater level data, flood-discharge zones, potential road drainage systems). To verify the data of the digitalized site plans and to accurately localize the still existing channels an on-site inspection was performed (see Figure 2).

For the local inspection a questionnaire was designed to examine the status quo of residual channels. Important questions were if a channel is still existing and if it is open or encased. Some other data about the vegetation, the presence of water and the connection to the main receiving water were also collected. Following the on-site inspection, the verified and additionally collected data was added to the existing GIS model. Based on the questionnaire potential measures were defined for the still existing channels.
